Discuss Budget Proposal for Interim Measures to Begin Addressing Coal Ash Clean-up and Monitoring

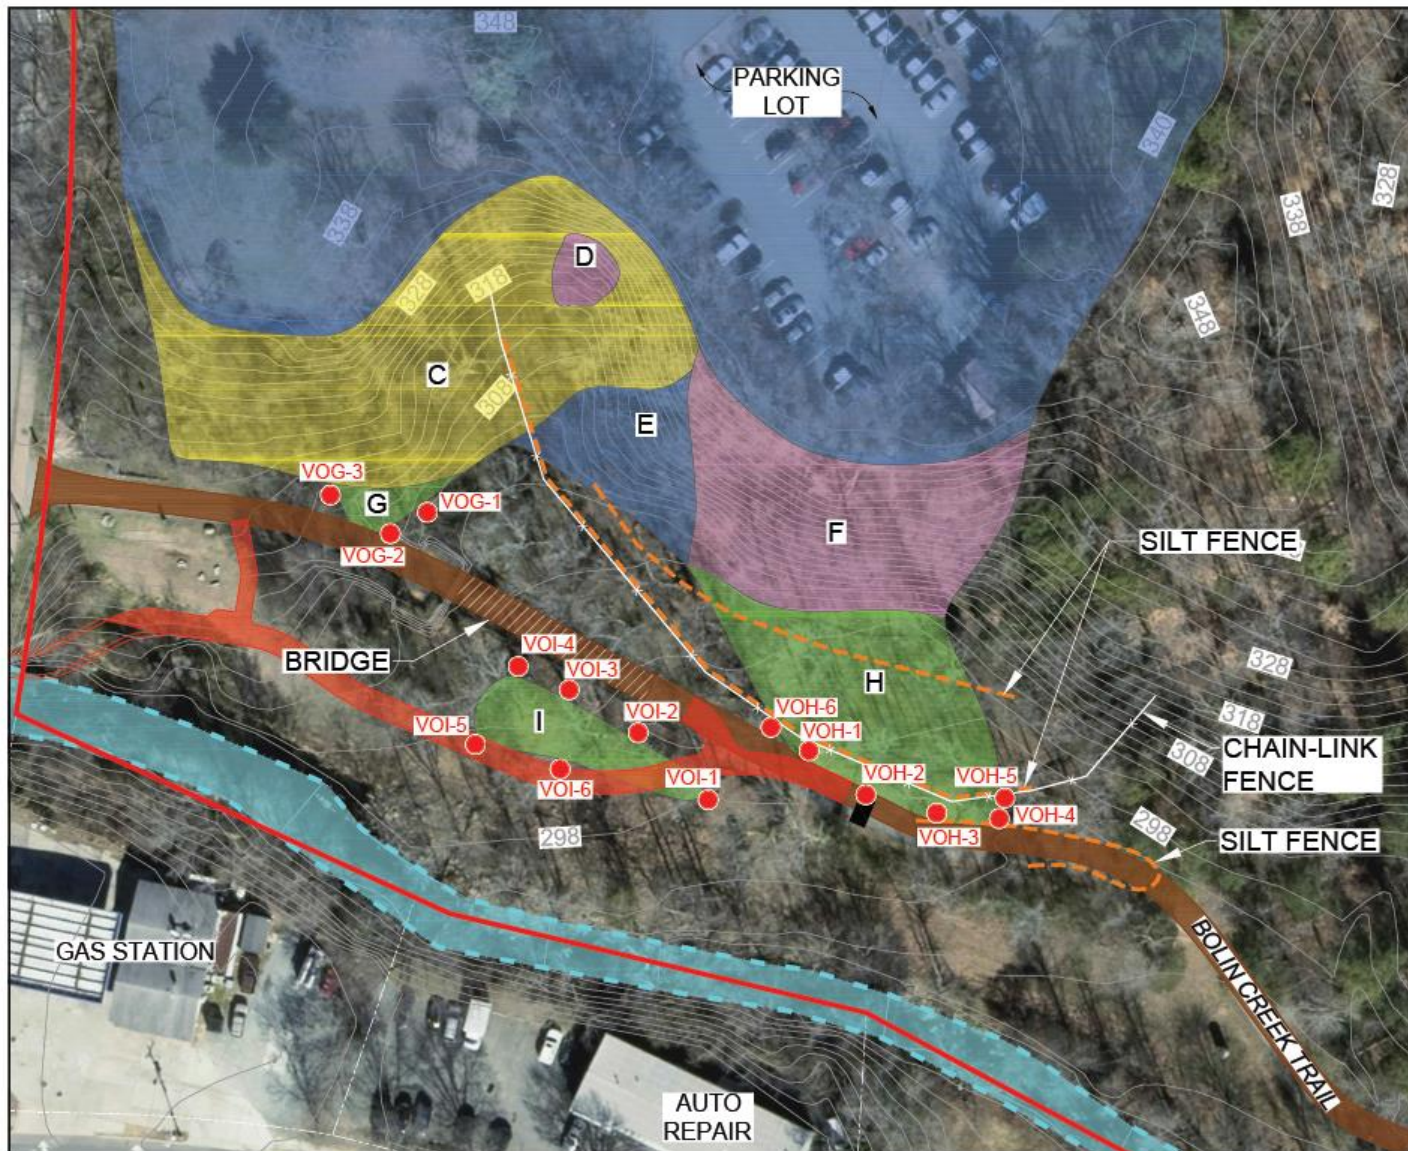
DATE: 5-10-19 REVISION NO. 0

0 50 100
