NC 54 Pedestrian and Bicycle Corridor Safety Study

Existing Conditions Report

8/21/2019

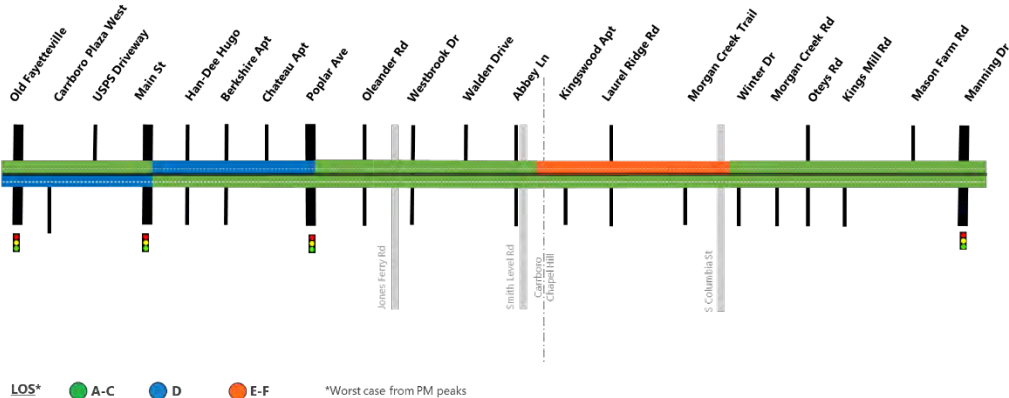
Figure 5 - Vehicular LOS – Segments

Vehicular LOS is calculated by estimating the average speed of vehicles along the segment and comparing it with the Base Free-Flow Speed. This analysis takes into account various roadway characteristics, such as number of lanes, shoulder width, median, number of access points, and downstream intersection operations. Figure 5 shows the LOS for each segment during the PM peak hour. Most segments are operating above LOS E.

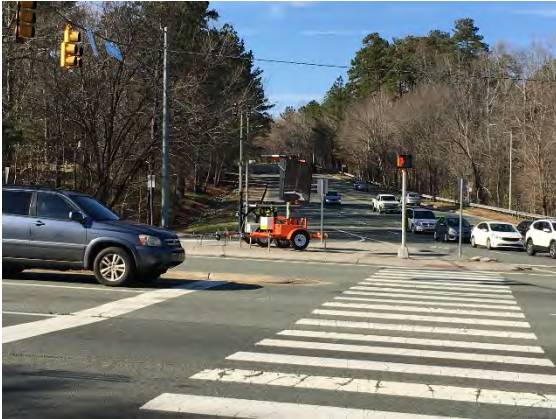
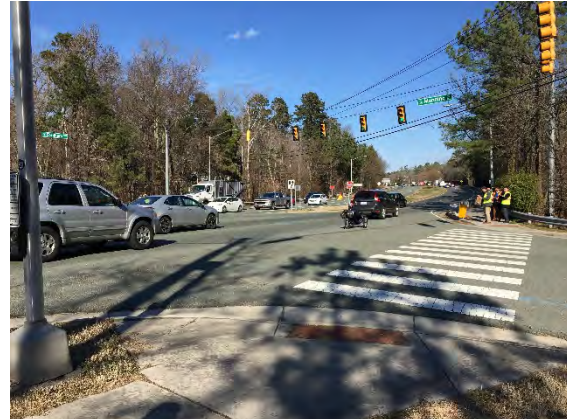
Figure 18 - Manning Drive Field Map

- No sidewalk present (south side). Steep slope along Manning Dr. Drainage below guardrail. Very unsafe crossing in any direction.
- Overhead tree canopy on north west corner. Free flow RT lane? If so, move pedestrian crossing nearer to beginning of radius to improve pedestrian conspicuity.
- Could add yield line at pedestrian crossing on right turn slip lane for emphasis. Bike loop signage is faded. Consider moving pedestrian crossing to north to improve visibility for south bound traffic.
- No pedestrian signal head on south east corner. Long green phase on NC 54. No sidewalk to the south on Manning Dr. No advance yield line on Manning Drive headed west to NC 54.

- Mysterious curb cuts on Manning Drive north of intersection. Bike markings are faded at Manning Drive north. Overhanging trees may limit visibility of pedestrians on north west side of intersection

**Manning Drive at NC 54 Intersection
Looking North**

**Manning Drive at NC 54 Intersection Looking
Northeast**

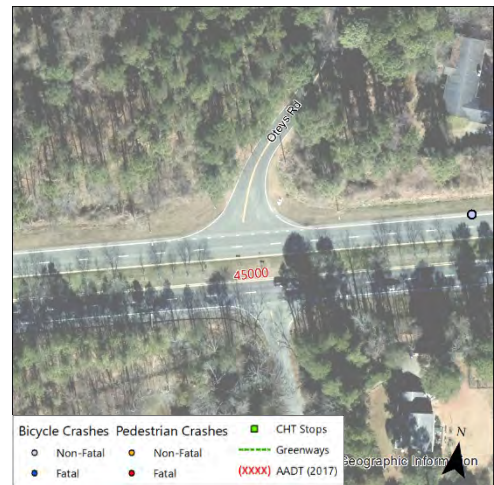
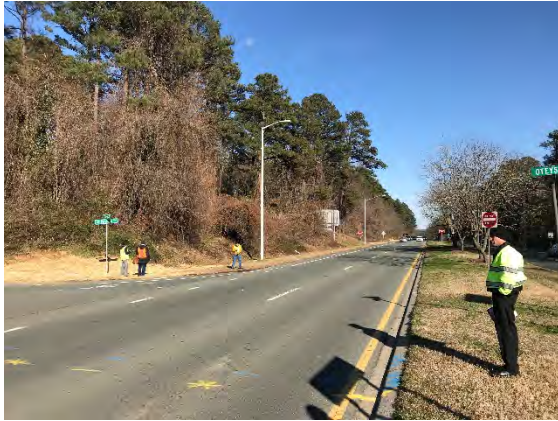
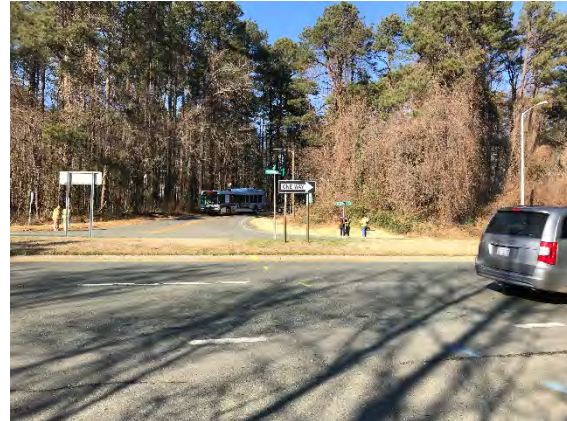
Figure 19 - Oteys Road Field Map

- Very steep slope. No visual cues to NC 54 traffic to expect bike ped crossings. No bike ped facilities and network on either side of road.
- Recommend Zig Zag crossing in median to reduce conflict with high speed right turns.
- Crest limits sight distance for east bound traffic (west of intersection). Street lighting in place.
- HAWK/PHB signal at intersection?
Future Morgan Creek greenway area.
Signal impacts gaps (from east)
- Broad median, high curb, and higher travel speeds. Street lighting at four corners. Low density walkable neighborhoods. Paved shoulder on NC 54 east ends well before Oteys Rd.
- Long crossing time, high speeds, and no pedestrian facilities
- Rise heading east make visibility to cross. No pedestrian lighting.

Oteys Road at NC 54 Intersection Looking East

Oteys Road at NC 54 Looking North

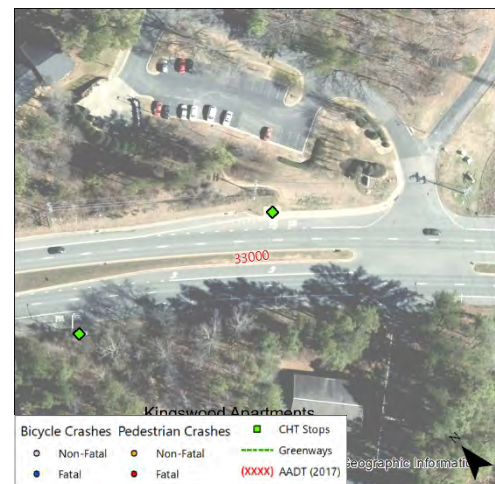
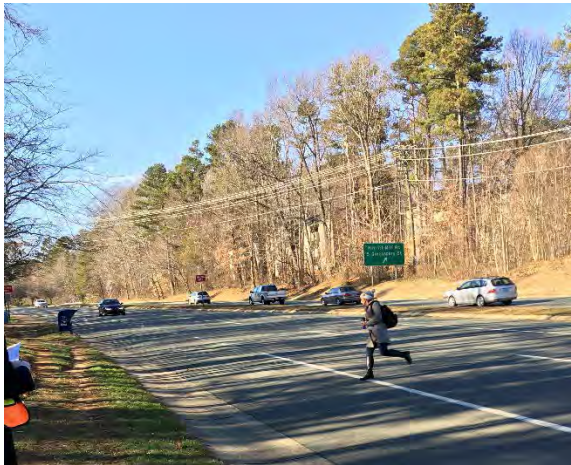
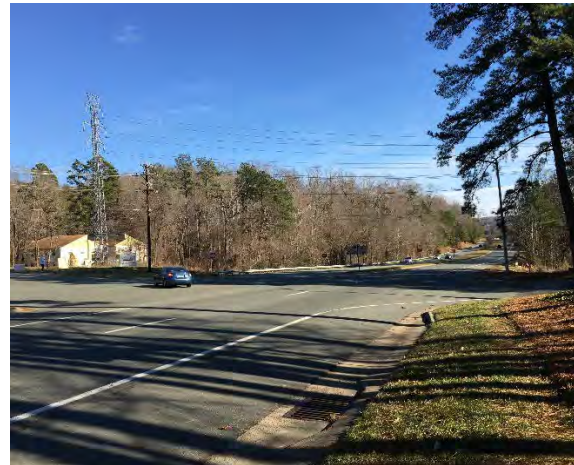
Figure 20 - Kingswood Apartments Field Map

- Consider near side bus stops, (see notes), consider left over for pedestrian refuge. Restripe existing bus lane as right turn acceleration lane
- Consider zig zag concept and moving bus stops.
- Talked to people who said dangerous at dark.
- No bus shelter on north side of NC 54. Three pedestrians crossed during visit. Pedestrians using median to stage crossing.
- Need sidewalk with ramps connectivity for bus stops. Rocky goat path in the median, south side connecting to bus stop.
- Consider left over.
- How necessary are bus pullouts?
- 1/4 mile to Morgan Creek Trail parking lot and poor sight distance

Kingswood Apartments at NC 54 Looking West

Kingswood Apartments at NC 54 Looking East

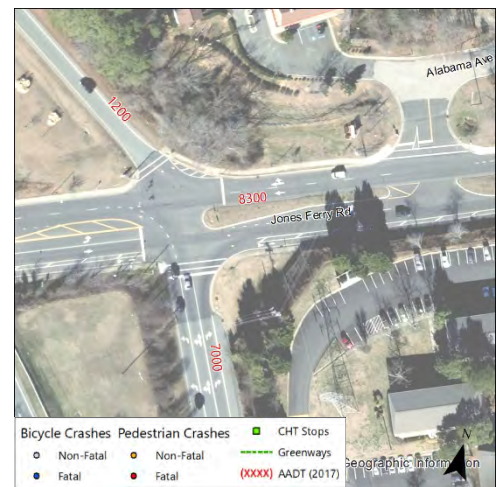
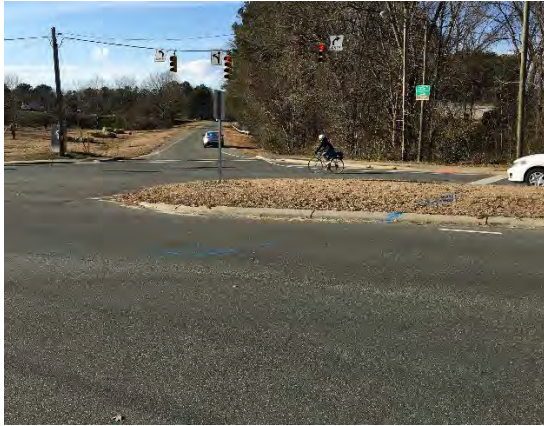
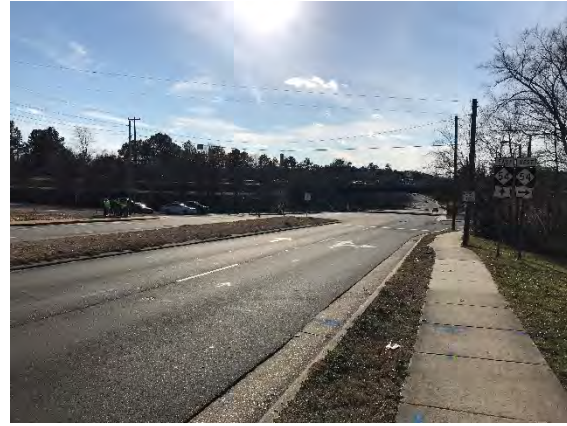
Figure 21 - Jones Ferry Road North Field Map

- Good sight distance to east and west. Right turns and poor sight distance. Place crossing to the north? Some people crossing at BP gas station.
- Consider adding crosswalk on east left of Jones Ferry Road, use island as refuge. Consider remarking crosswalks across ramp to promote pedestrian visibility to right turn motorists. Obtain ROW for sight triangle and vegetation management in North east quad.
- Overhead tree canopy produces shade at pedestrian ramp. Add pedestrian signals. Replace pedestrian sign removed for fiber optical install.
- Revisit crossing configuration on north side of Jones Ferry Road. Consider no right turn on red.
- No pedestrian heads. Vegetation on south west corner block visibility. Existing street light on south west corner.

Jones Ferry Road Looking East towards NC 54 West On-Ramp

Jones Ferry Road Looking South towards NC 54 Ramps

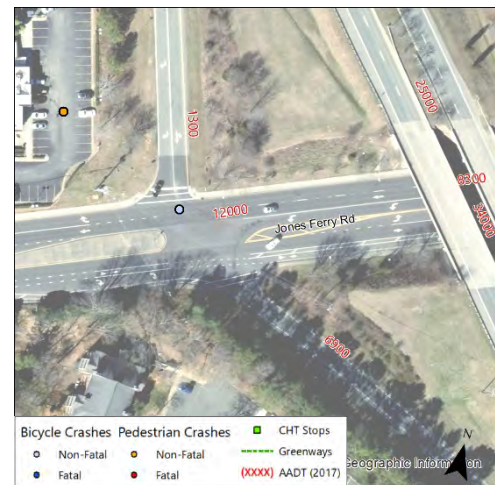
Figure 22 - Jones Ferry Road South Field Map

- Is this a State bike route? Is there lighting under bridge? Mismatch of bus stop. North bound bike lane plus separation.
- No marked crossing [across Jones Ferry Rd]
- Conflict with on ramp and crosswalk.
- Lighting on westside. No crosswalks across Jones Ferry.
- Sidewalks with curb ramps. Bus stop south of intersection. Crosswalks across Jones Ferry Road at shopping center south of ramps.

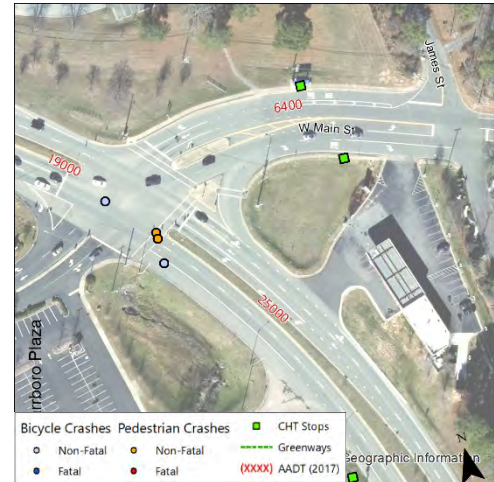
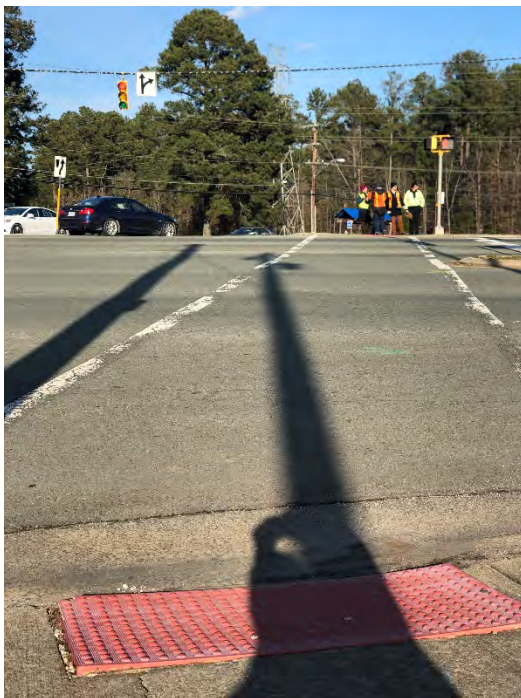
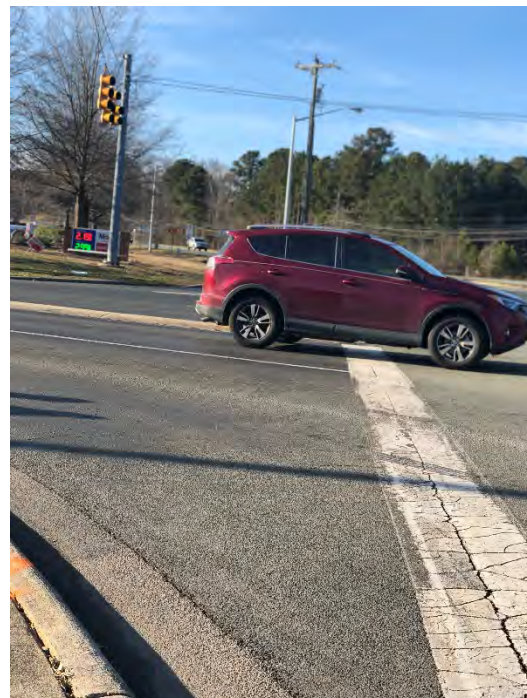
Figure 23 - Carrboro Plaza Field Map

- Crosswalk could be better with two padded white lines. Degraded low viz crosswalks
- Short crossing time for Main St. No protected left for the cross streets so [vehicles] cross in front of pedestrians . Bus stop away from intersection but close to ABC store.
- Curb cuts across plaza driveway but crosswalks on sidewalk. No sidewalks along NC 54.
- Foot traffic in median. Remove detectable domes to nowhere on southwest corner of intersection. Detectable plates in poor condition in similar location. Bus stop in front of ABC store.
- High crest and sun in drivers' eyes at intersection. Needs protected left from Main St.

**West Main Street and NC 54 Intersection
Looking Northeast**

**Entrance to Carrboro Plaza at NC 54 Looking
West**

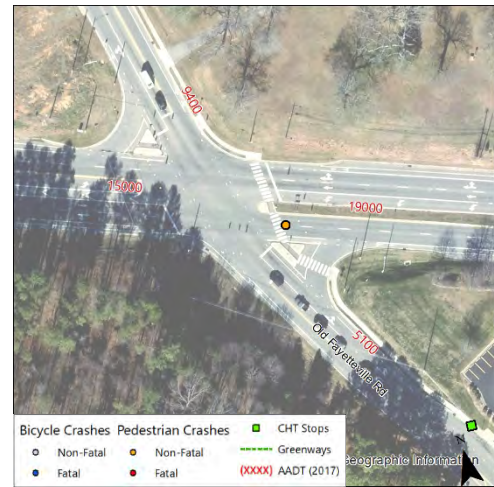
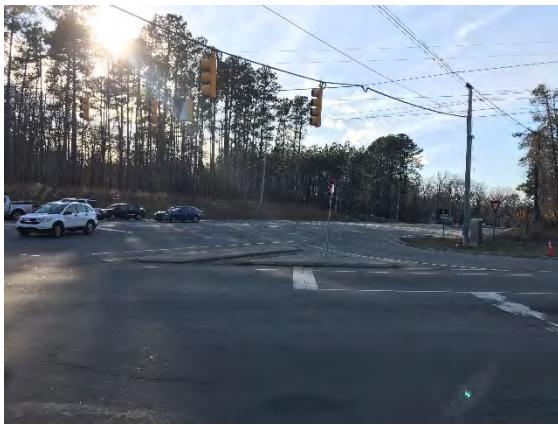
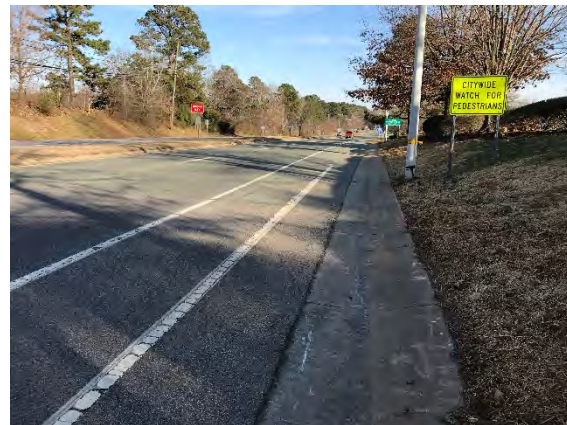
Figure 24 - Old Fayetteville Road Field Map

- No crosswalks at porkchop on north side of intersection. Look into peak hour "No Turn on Red" signage. Re-evaluate signal timing for protected turns and when WALK phase is on.
- No lighting. Pedestrian crossing on NC 54 on permissive Ø, may not be readily visible to SB Old Fayetteville left turn traffic.
- Blank out sign? Left turn on permissive phase during pedestrian phase. This is a long left turn, can turning vehicles see pedestrians?
- Two stage crossing on NC 54 east of intersection.

Old Fayetteville Road and NC 54 Intersection

NC 54 Looking East from Old Fayetteville Road
