Town of Chapel Hill Eastwood Lake Subwatershed Study

Eastwood Lake Subwatershed Study Volume I: Report

WKD # 20170067.00.RA

June 2020

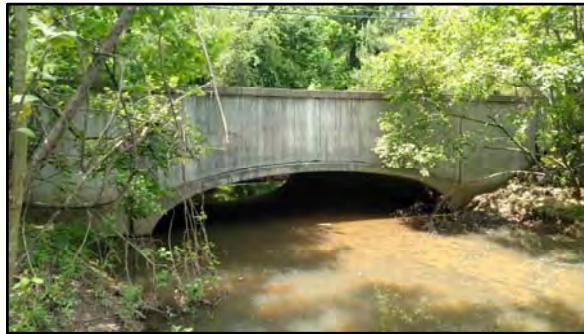
Picture 3-1: North Lakeshore Drive Bridge

Location	Size/Material	Condition
North Lakeshore Drive	Bridge	Good
Piney Mountain Road	Bridge	Good

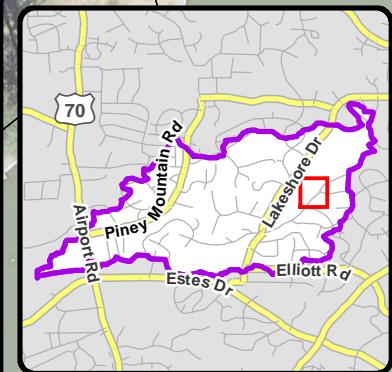
Figure 3-6
South Lakeshore Drive/
Ridgecrest Drive System
Existing Conditions

There is one (1) report of flooding adjacent to this system. The resident at 1825 South Lakeshore Drive has reported experiencing yard flooding at 2 to 3 times a year. This occurs during heavy rainfalls when the water runs down Woodhaven Road into the driveway and yard at base of the roadway. Previously, the resident at 1901 South Lakeshore Drive experienced similar yard flooding. A section of curb and gutter was installed along the front of the property to convey the runoff.

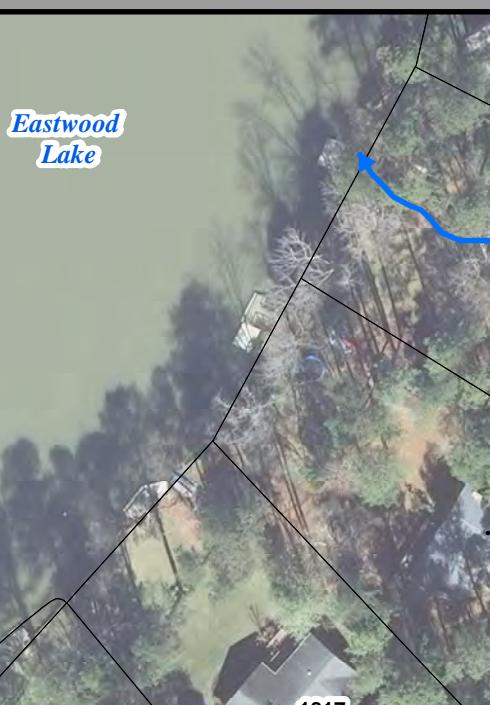
Figure 3-8
South Lakeshore Drive/
Rolling Road System
Existing Conditions

Figure 3-8 shows the level of service being provided by the existing system. Nearby non-modeled pipes are shown on the figure; however, they were not included in the model because they are not connected to the South Lakeshore Drive/Rolling Road System. The model results show that the existing system is operating below a 2-year level of service, which is less than the desired 10-year level of service. The residents at 1817 and 1820 South Lakeshore Drive both reported flooding. The resident at 1817 South Lakeshore Drive experiences yard, crawl space, and storage building/shed flooding less than once a year. The property owner installed a French drain to alleviate the flooding. The resident at 1820 South Lakeshore Drive reported street flooding.

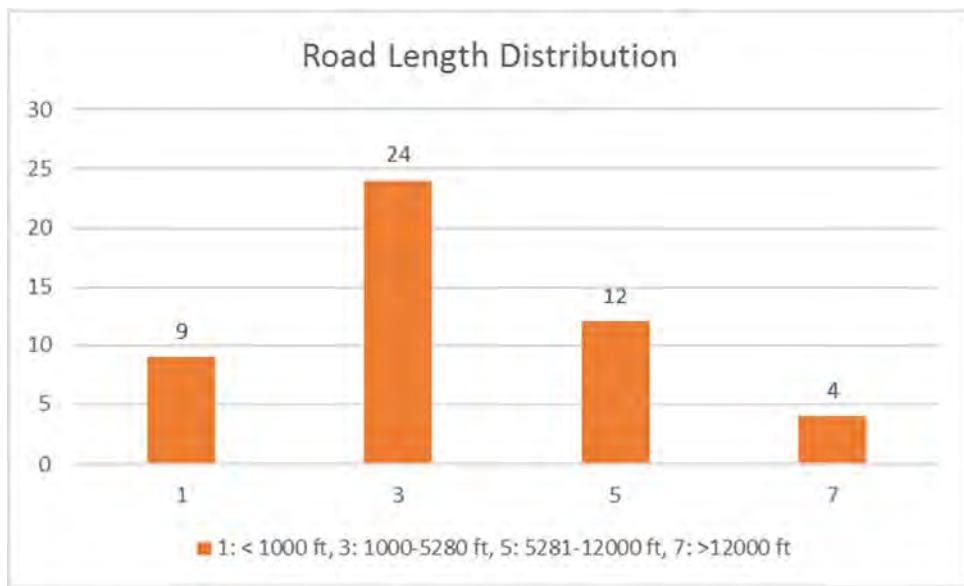
Exhibit 3-5: Road Length Distribution

Total road length was measured using the GIS roadway centerline layer. The length of all road segments within the neighborhood boundary were added together to determine the total road length for each neighborhood. Neighborhoods with more linear feet of roadway were given a higher score. For the forty-nine (49) neighborhoods included in the analysis, the total neighborhood road length ranged from 3 linear feet (for neighborhood most likely bisected by a subwatershed divide) to 15,723 linear feet with a mean value of 4,572 linear feet. The scoring for this parameter is defined as follows: a score of one (1) indicates a total road length below 1,000 linear feet; a score of three (3) indicates a total road length between 1,000 linear feet and 5,280 linear feet; a score of five (5) indicates a total road length between 5,281 linear feet and 12,000 linear feet; and a score of seven (7) indicates a total road length greater than 12,000. Exhibit 3-5 shows the score distribution of this parameter.

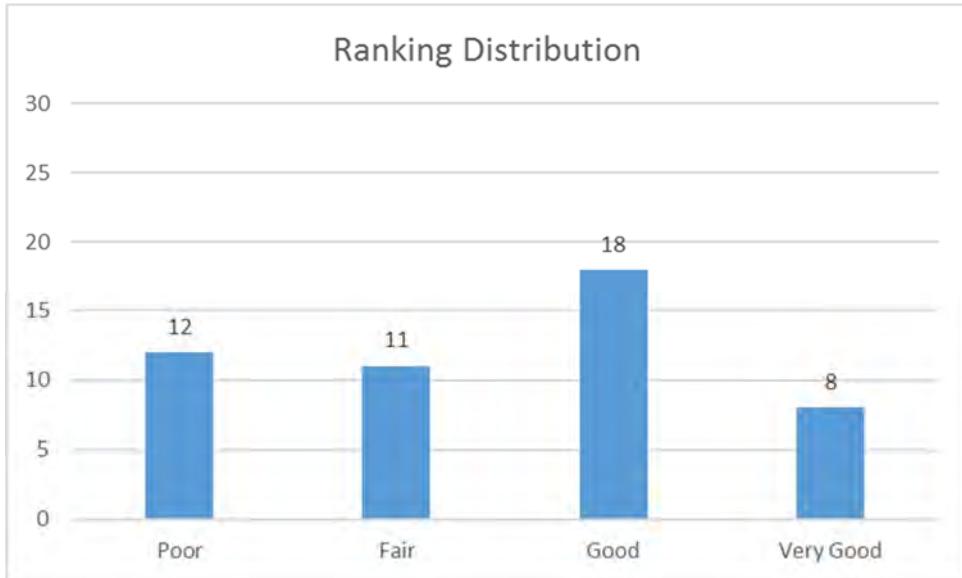
Exhibit 3-6: Ranking Distribution

The scores for each parameter were then added together to compute a final neighborhood score. These total scores were then compiled into four (4) ranking categories (poor, fair, good, very good) to represent the favorability of a neighborhood to retrofitting (See Exhibit 3-6 and Table 3-9). A ranking of poor indicates a total score below sixteen (16), meaning that the neighborhood is unsuitable for retrofit. A ranking of fair corresponds to a total score between seventeen (17) and twenty (20), indicating that the neighborhood most likely scored poorly in one (1) of the five (5) parameters. A ranking of good corresponds to a total score between twenty-one (21) and twenty-four (24), indicating that the neighborhood is likely to be a suitable candidate for retrofit projects. A ranking of very good corresponds to a total score of twenty-five (25) or more, indicating that a neighborhood scored well in all categories.

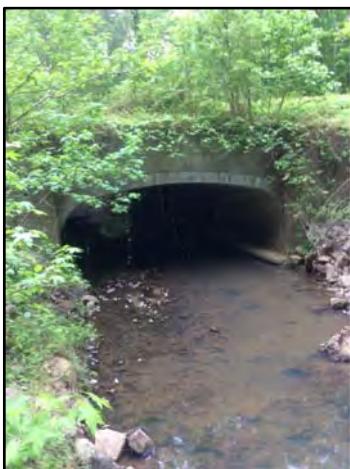
Picture 4-1: Piney Mountain Road Bridge

analysis, the roadway is overtopped by 0.5 feet during a 10-year storm event. The existing and future conditions do not meet the desired 100-year level of service for roadways located within a FEMA regulated floodway.

With the implementation of the three (3) proposed detention projects in Section 4.1, the resulting 10-year water surface elevation will be decreased by 2.1 feet while the resulting 25-year water surface elevation will decrease by 0.3 feet.

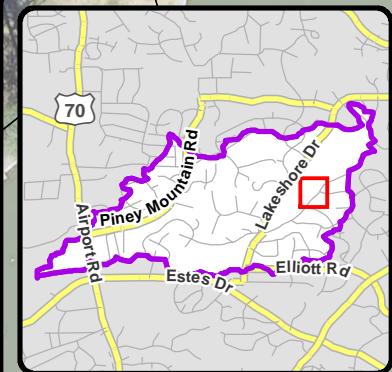
Figure 4-8
South Lakeshore Drive/
Ridgecrest Drive System
Alternative

The proposed improvements will provide the desired 10-year level of service for the South Lakeshore Drive /Rolling Road Closed System. While a significant portion of the project will be located within the public right-of-way, there will be approximately 30 linear feet that will be located on private property. The driveway and landscaping at 1812 South Lakeshore Drive will be impacted. Underground water and sanitary sewer lines were identified as potential utility conflicts. Other potential site restrictions include overhead power lines. The total estimated cost for the recommended alternative is \$216,800. Due to their close proximity, the proposed improvements to the South Lakeshore Drive/Rolling Road system should be coupled with the adjacent stream stabilization recommendations shown as Project 9 – Allard 2 in Section 6.1 (Page 6-9).

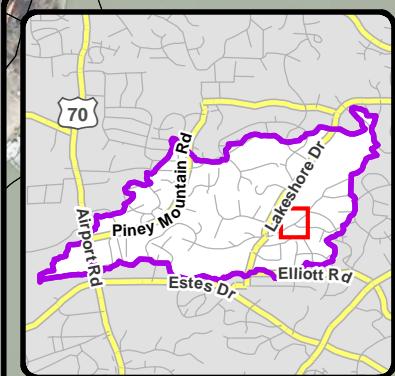
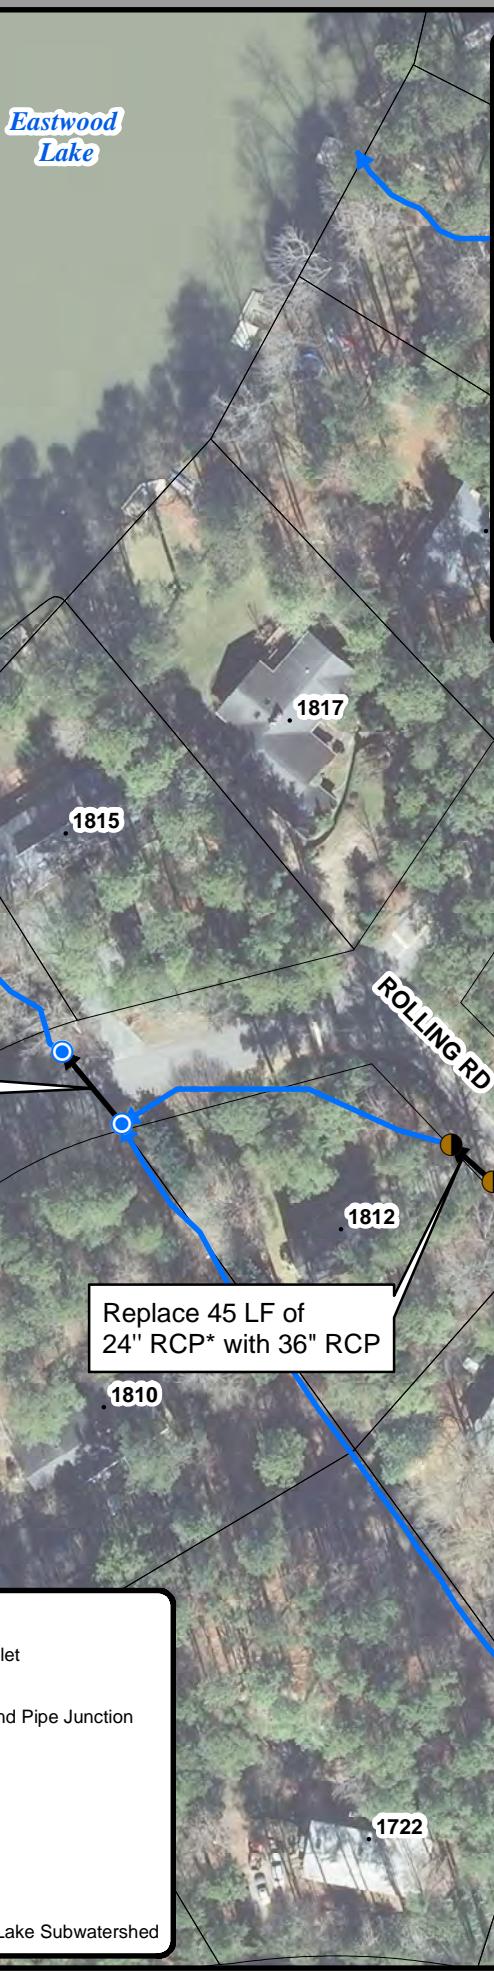
Figure 4-9
South Lakeshore Drive/
Rolling Road System
Alternative

WK Dickson recommends the following improvements for the South Lakeshore Drive /Rolling Road Closed System as shown in Figure 4-9:

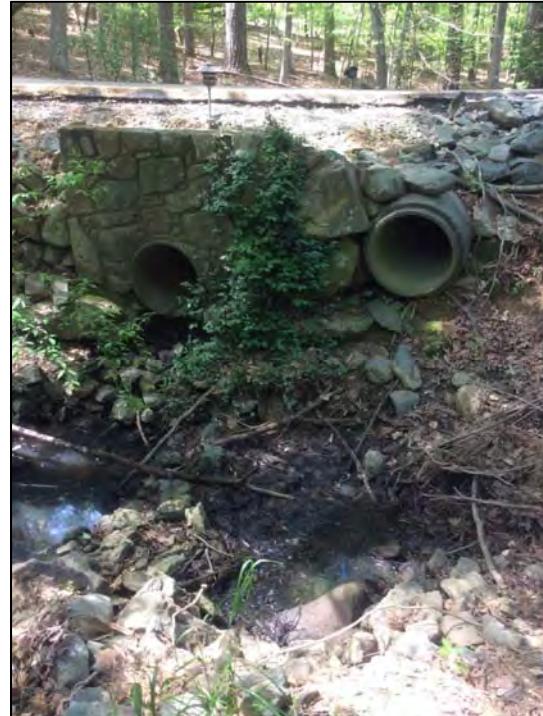
Picture 6-1: Woodshire 2 – Driveway Culverts

The proposed project would likely include stabilization of the channel near eroding driveway crossings, including resolving the perched culverts. The Town should consider moving the stream to the north immediately downstream of the 217 Huntington Drive driveway crossing, which could allow for incorporating restoration techniques and reduce the potential for structural damage to the nearby residences. Private property owner approval would be required for the project to move forward. If the homeowners are not interested in moving the stream, additional spot bank stabilization would be required. The sewer easement provides good access to most of this reach.

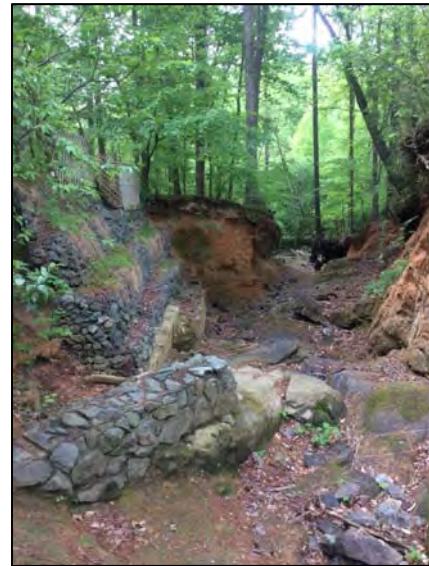
Picture 6-3: Lake Ellen 1 – RSC Opportunity

Lake Ellen 1 is a short reach located south of Lake Ellen Drive, downstream of Lake Ellen between two (2) residential properties. The channel is very deeply incised, and the banks are eroding and falling into the channel. Repair options are to: (1) stabilize the channel in place, with grade control and hardened structures along the channel to control bank erosion; or (2) install a regenerative stormwater conveyance or similar device, which creates a sequence of step pools out of an underlying substrate of sand and mulch, with boulder structures used to stabilize the channel bed and banks. The site can be most easily accessed from the sewer right of way on Booker Creek. Repairs on this site are challenging due to access and the deeply incised condition of the existing channel.

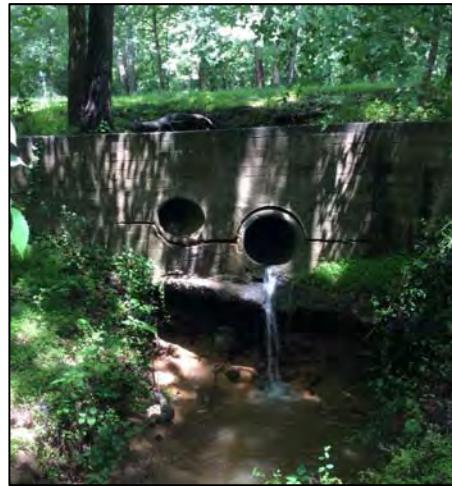
Picture 6-5: Croom – Perched Culvert

The Croom reach is located south of Rock Creek Road, downstream of the upstream reach that parallels Croom Road. The outfall under Croom Road is perched approximately 5 feet above the channel and extensive erosion is taking place here threatening the future structural integrity of the culvert and the road above. Downstream, the channel needs stabilization where it is incised approximately 2 to 3 feet. The sewer easement provides good access to this reach.

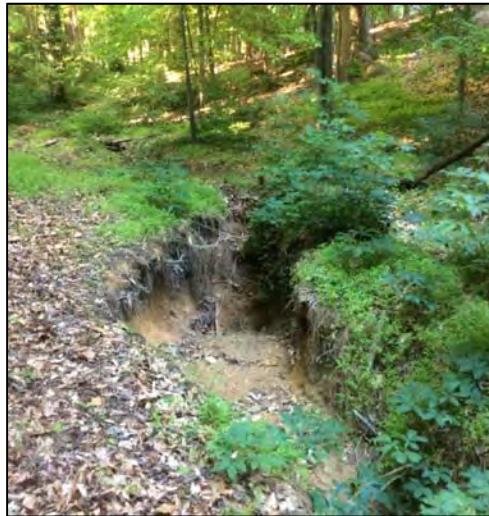
Picture 6-7: Lyons 1 – Bank Stabilization

Lyons 1 collects runoff from Michaux Road and Audobon Road flowing north through private properties to a 30" RCP pipe system at Allard Road. The steep stream has significant head-cuts and bank erosion resulting in sediment loads entering directly to Eastwood Lake downstream of the forebay. A sanitary sewer line is located along the west bank and may be contributing to the bank erosion. Repairs in this reach include establishing reliable grade control in the channel bed, repairing the head-cuts, protecting the sewer line system, and establishing riparian buffer vegetation. Access is good along the sewer easement.

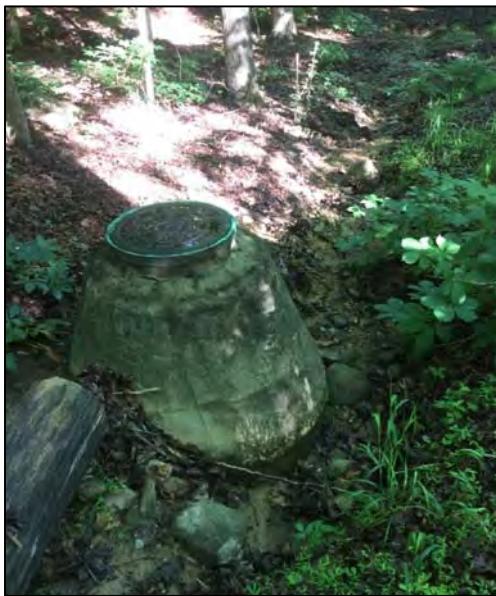
Picture 6-9: Ridgecrest 1 – Existing Sewer Manhole

Ridgecrest 1 is located in a sewer right-of-way northwest of Woodhaven Road and west of Ridgecrest Drive, and is the southern fork of the upstream end of the reach. Runoff on the steep terrain has created multiple head-cuts and streambank erosion. The project consists of establishing reliable grade control in the channel bed, stabilizing channel banks, and moving the channel to protect the sewer infrastructure that is currently in the channel. Access to the channel is fair along the sewer easement.

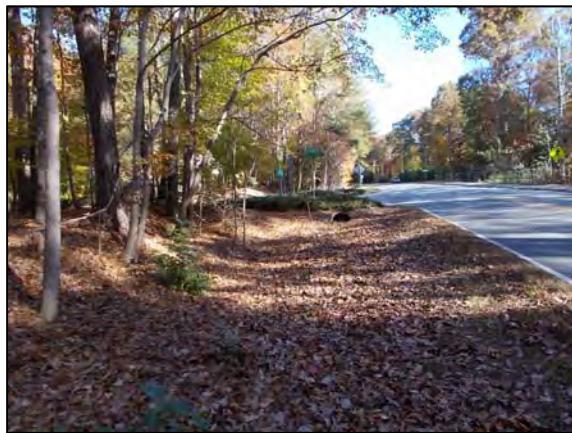
Picture 6-11: EL0431

Proposed Retrofit: The proposed opportunity is a linear ROW bioretention facility within the existing ephemeral drainage channel at the downstream end of a 24" culvert. There is additional space available along the roadway to treat 0.1 acres of impervious drainage area in a location with few anticipated tree impacts. This location is situated within the existing drainage network downstream of the opportunities identified at EL00541.

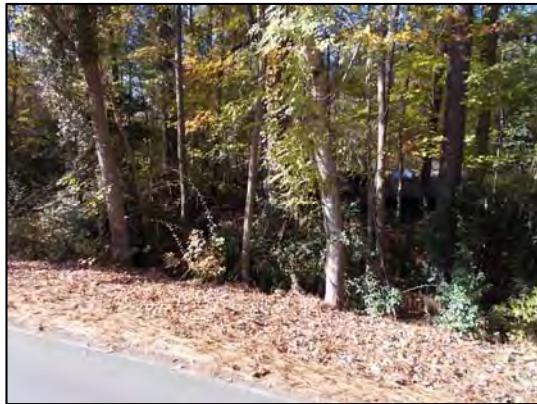
Picture 6-12: EL0389

Potential Constraints: There are potential traffic impacts associated with the construction of this measure.

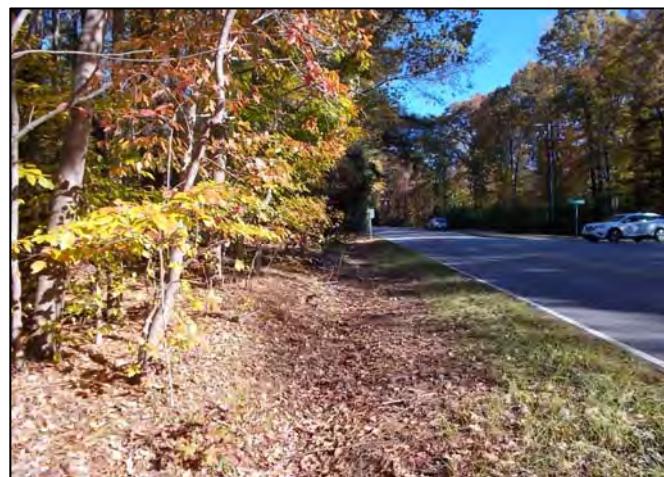
Picture 6-13: EL0541

Comments: No outlet found visually at this location, counter to the GIS information, but might be obscured by sediment or buried. However, there is an opportunity to treat roadside stormwater flow with relatively minimal disturbance. This site is just upslope from EL0431 and the outflow from this location would be in series with any potential device located at EL0431.

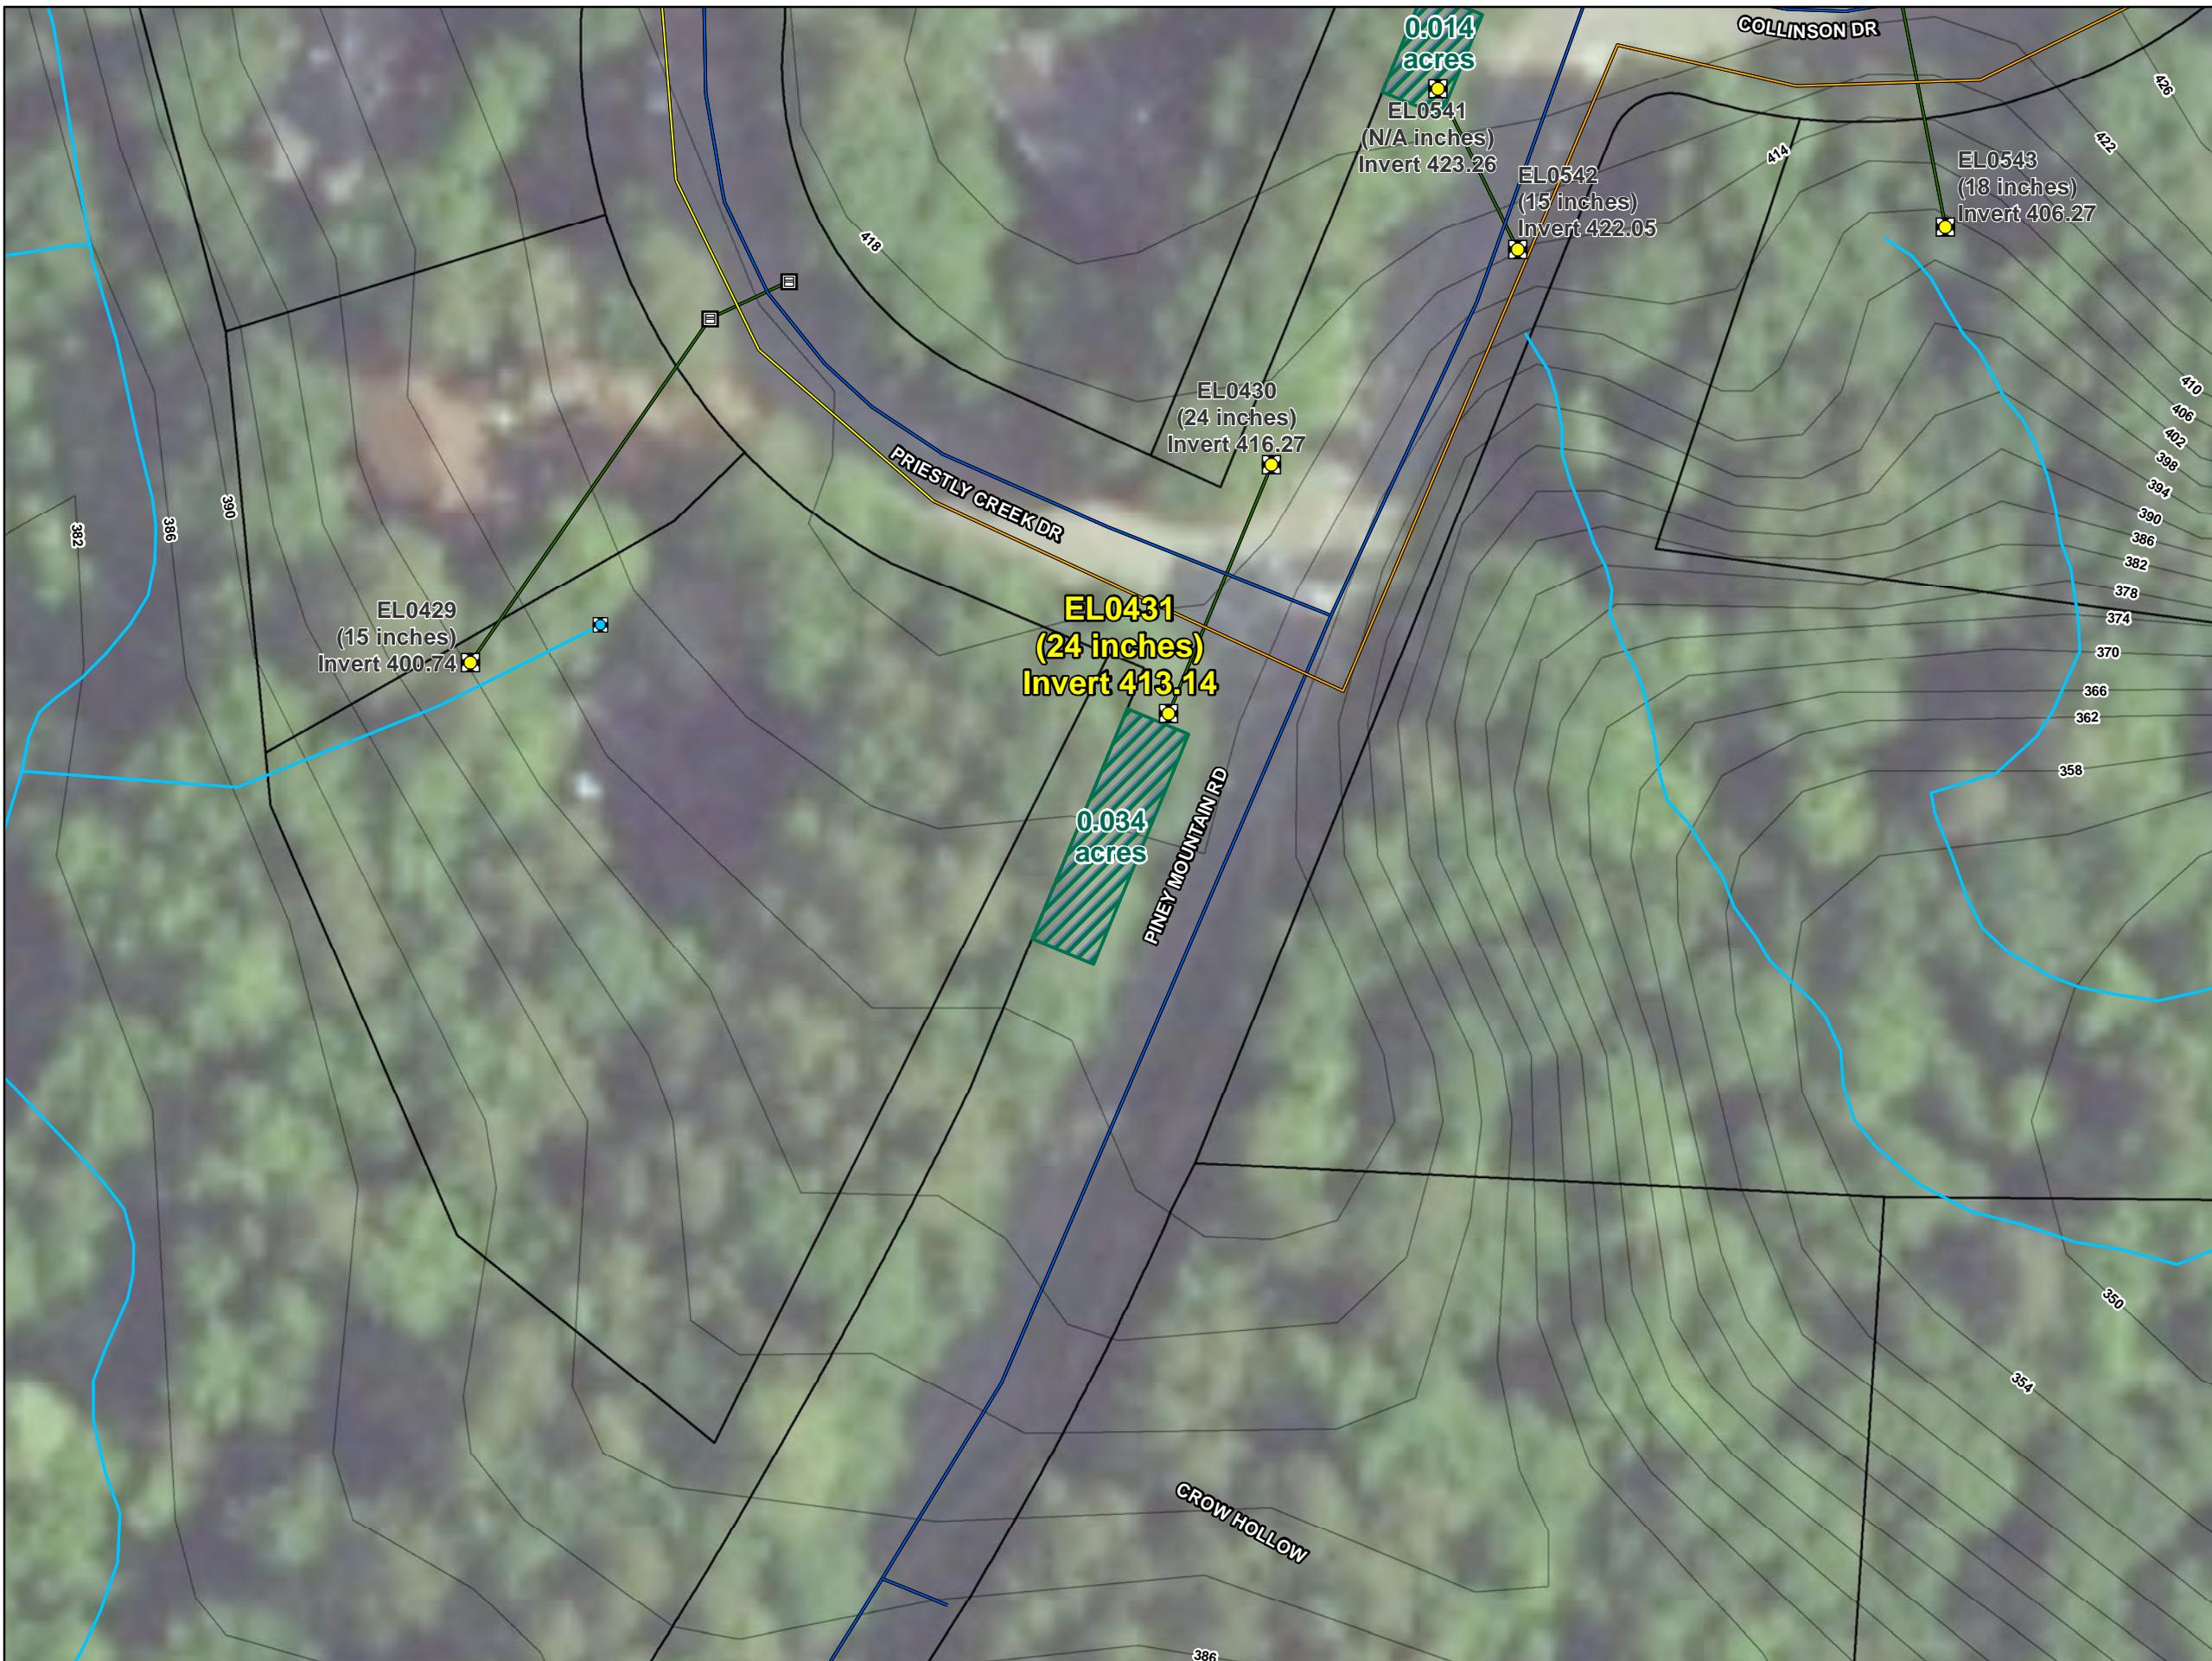
Figure 6-3

Location: Within ROW on west side of Piney Mountain Road, south of intersection with Priestly Creek Drive (See Figure 6-3).

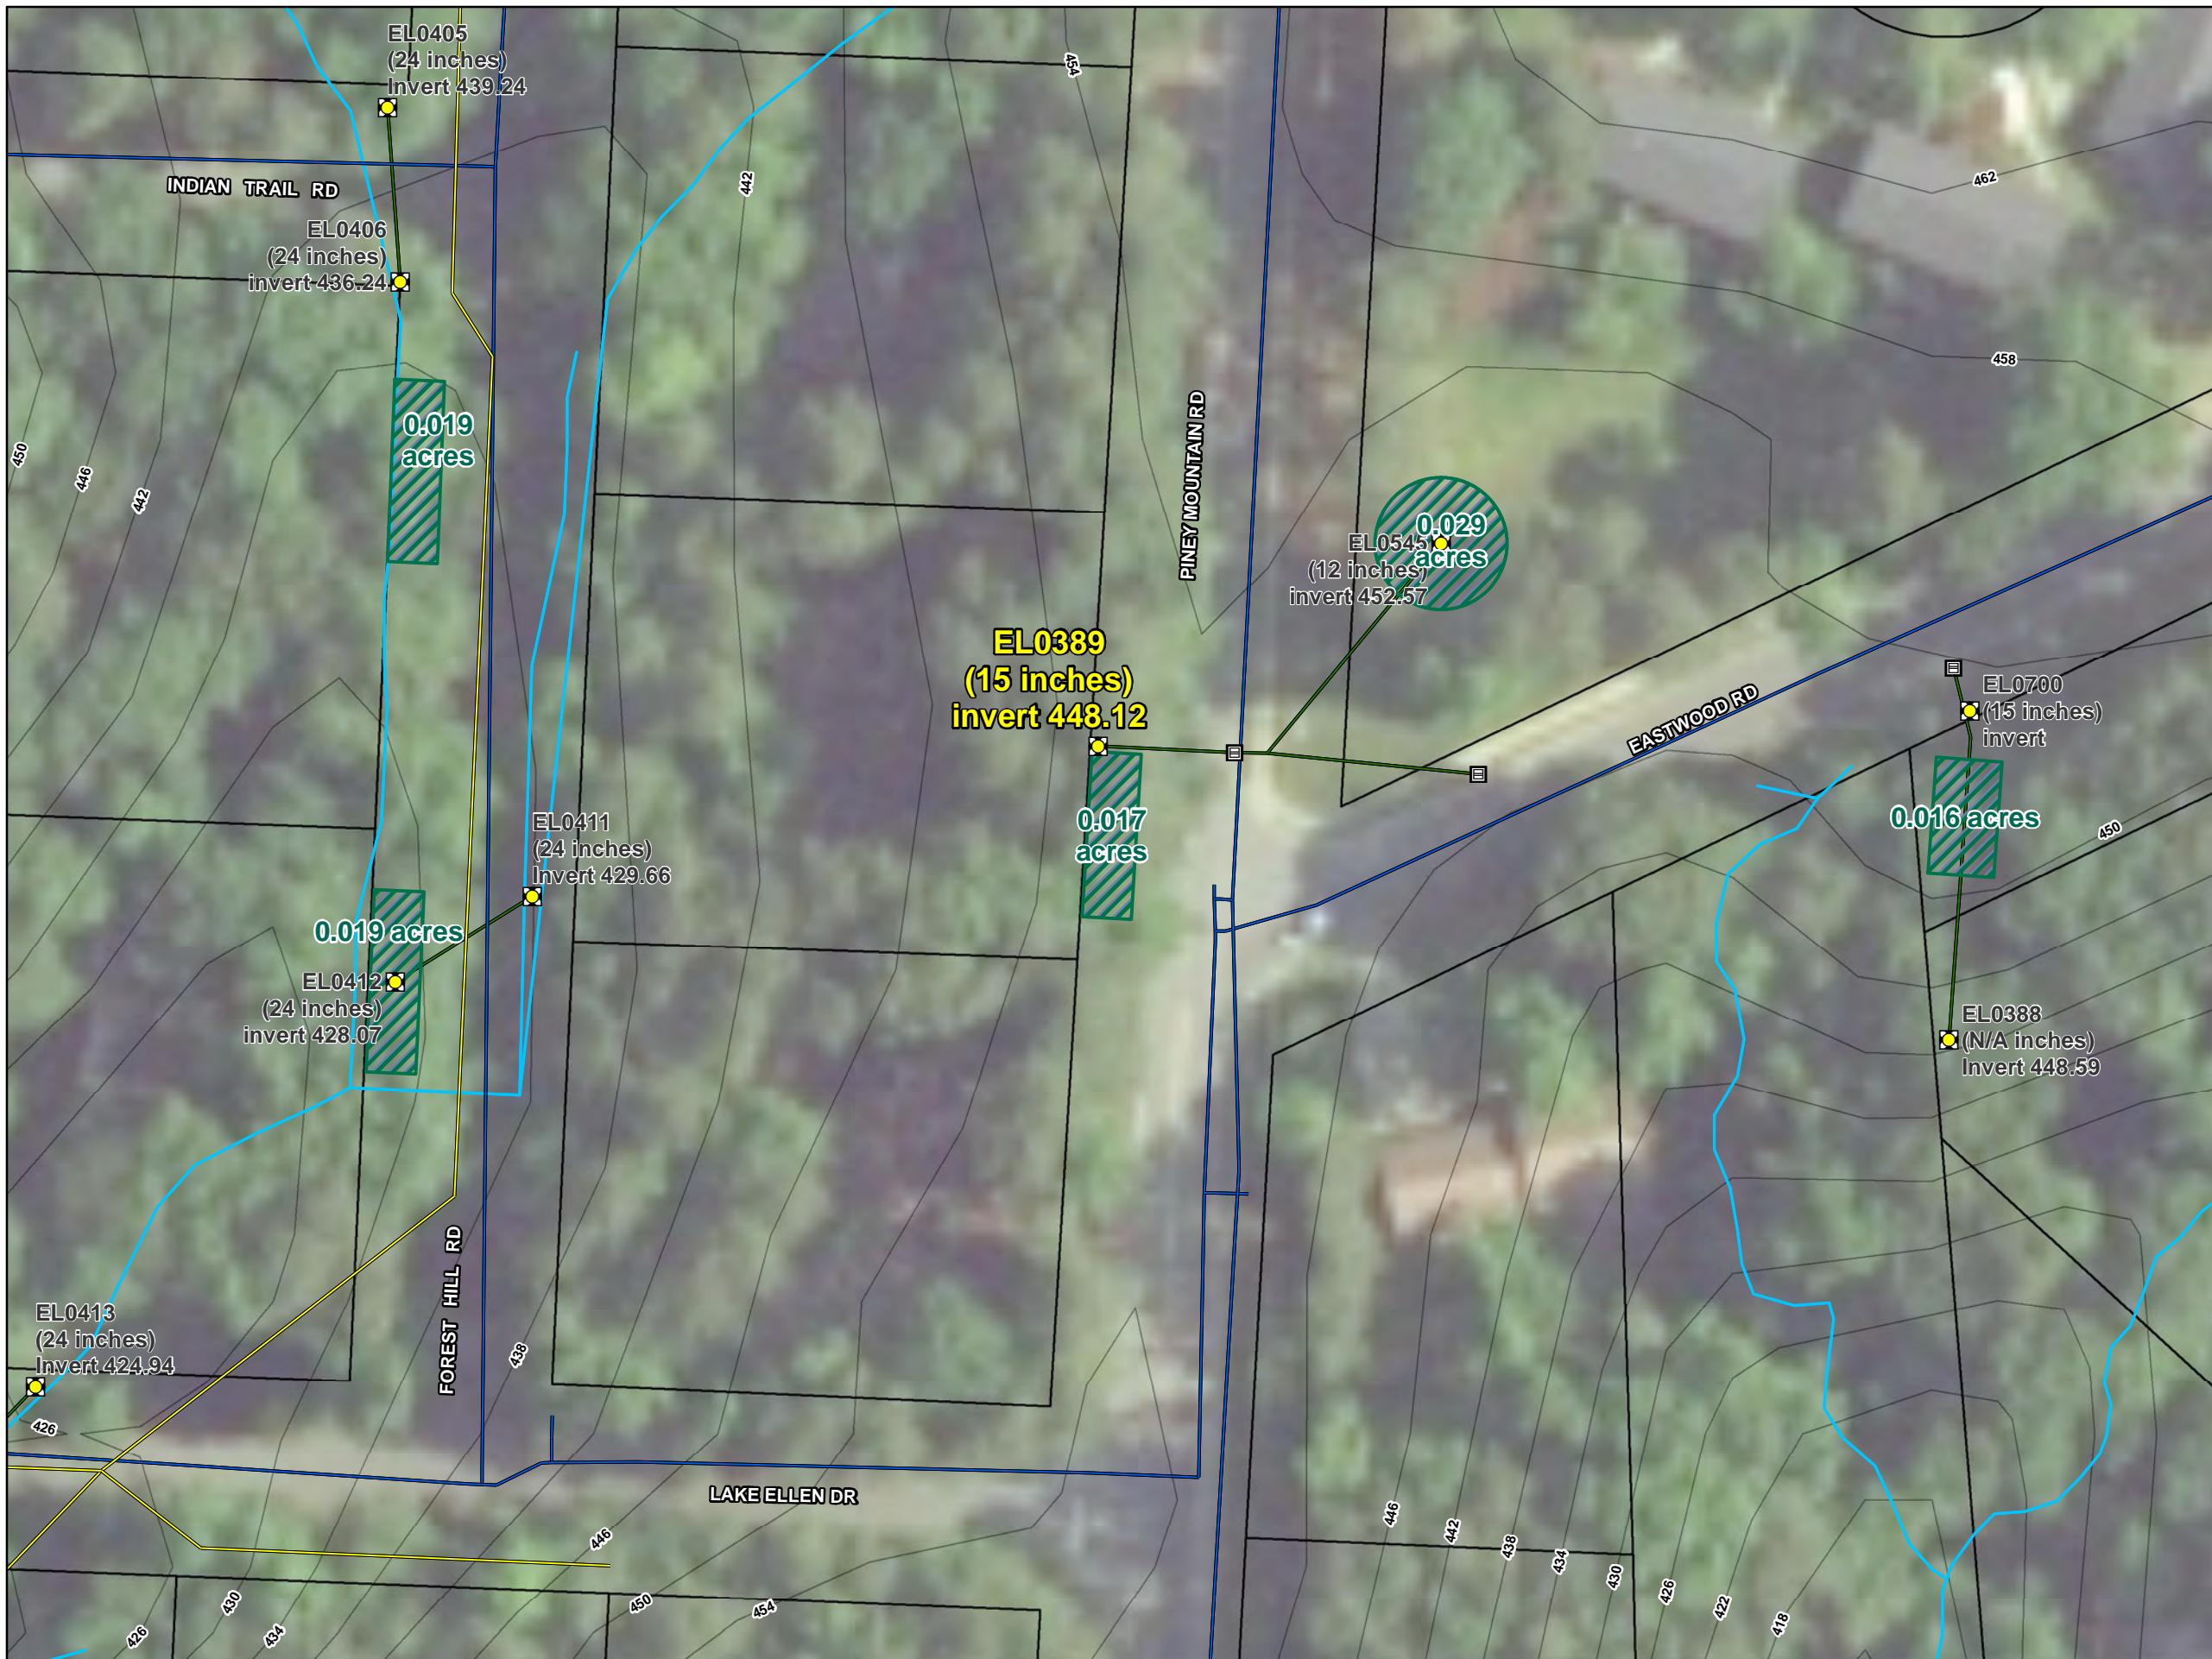
Figure 6-4

Location: Within ROW on west side of Piney Mountain Road at Eastwood Road (See Figure 6-4).

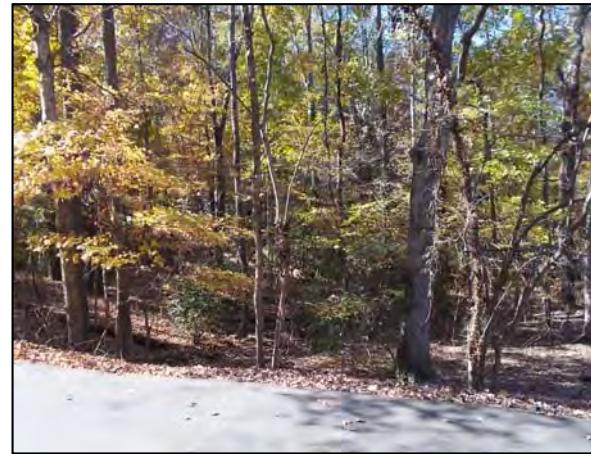
Picture 6-14: EL0109

Potential Constraints: There are few constraints associated with this site. It is possible that there may be some minor traffic or parking impacts during construction.

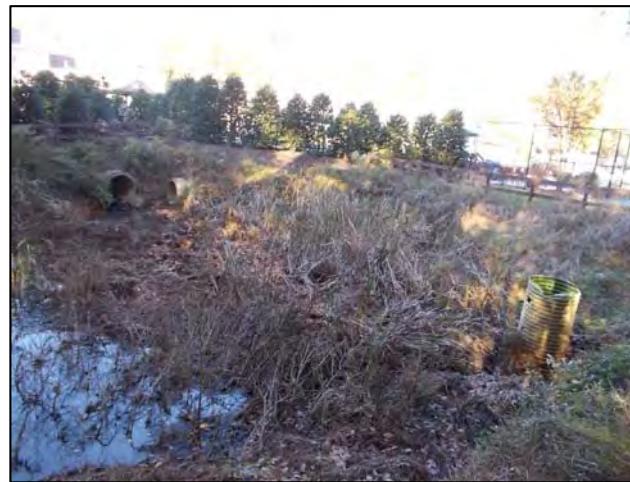
Picture 6-15: EL0343

Comments: To expand the capacity of the existing SCM, many trees that have established on its banks would have to be removed. The retrofit could be designed to be an amenity that provides wetland habitat. The photo is looking northwest across the SCM, from the area near the riser/dam (See Picture 6-15).

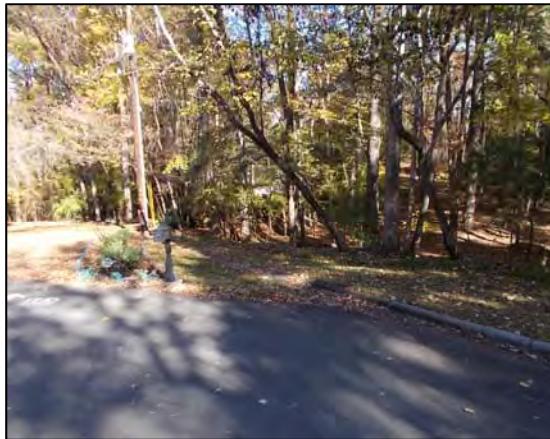
Picture 6-16: EL0074

Proposed Retrofit: There is adequate room here to provide some level of water quality treatment for a large portion of the 1.5 acres of impervious area that drains to the outfall. The retrofit concept is to construct an inline bioretention facility within the ephemeral channel. If inline bioretention is determined unfeasible at this location, there may be sufficient space for offline bioretention with the installation of a flow splitter at the outfall.

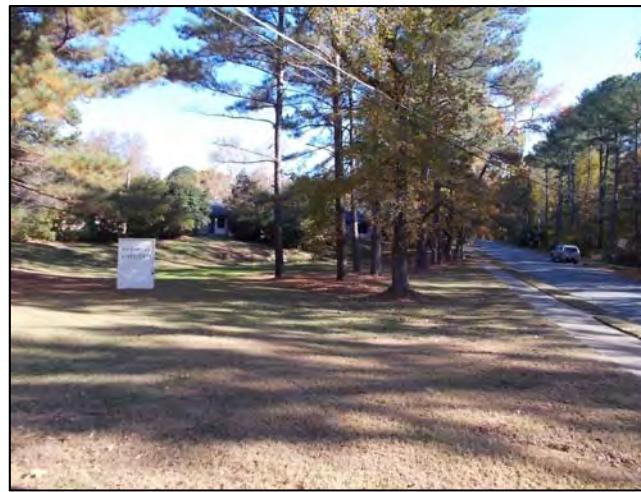
Picture 6-17: EL0545

Comments: There was no outlet found/located at this site, counter to the GIS information. No constraints were documented. It is likely that several large trees would have to be removed to direct flow from Eastwood Road to the site. The picture is looking northeast with Eastwood Road on the right side of the image. This site is upslope of and drains to EL0389.

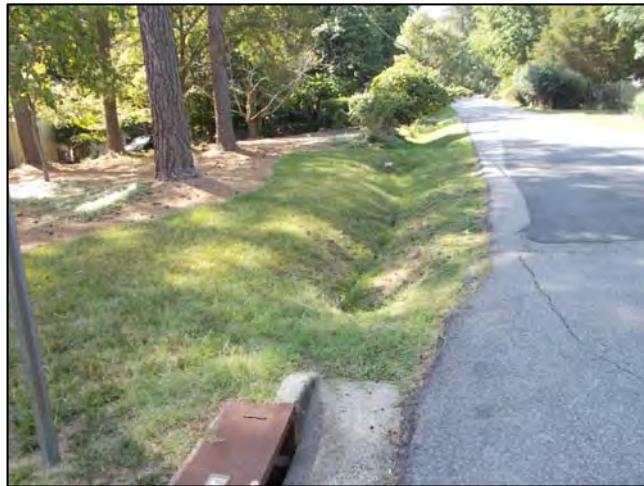
Picture 6-18: EL0200

Location: Southwest of Linneaus Place cul-de-sac (See Figure 6-11).

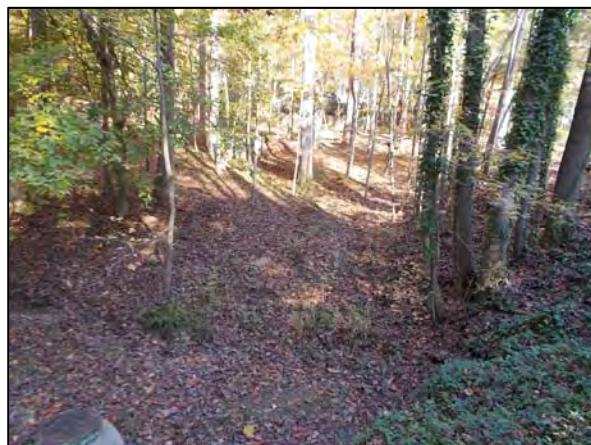
Picture 6-19: EL0523

Proposed Retrofit: The proposed retrofit is to create a bioretention cell in a poorly defined ephemeral channel to treat runoff from Linneaus Place and adjacent homes prior to discharging into the intermittent channel downstream.

Comments: The site is on private property and several trees greater than 12 inches diameter breast height would have to be removed to construct. The picture is looking north from a private residence driveway onto the site (See Picture 6-19).

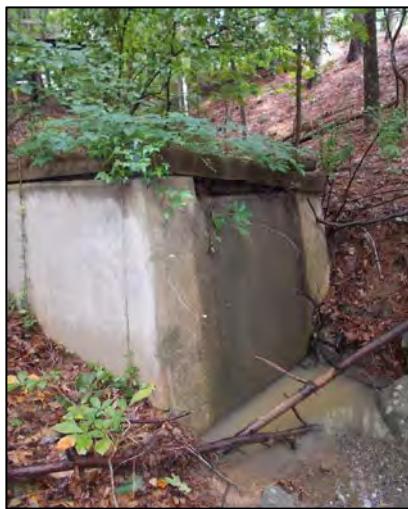
Picture 6-20: EL0157

Description of Observed Problems/Opportunity: This site has two (2) unmaintained stormwater dissipaters that flow into separate channels that converge just downstream and form a single channel that flows through an undeveloped lot (See Pictures 6-20 and 6-21).

Comments: The existing dissipaters apparently treat water piped down the steep hill from Arlington Street to the northwest. The design will need to accommodate the needed energy dissipation and storage needs.
